UNITED STATES ENVIRONMENTAL PROTECTION AGENCY

MEMORANDUM

SUBJECT: GAF Transite Plant, St. Louis, Missouri
(SBR60)

At the request of the Air and Toxics Division (ARTX), the Environmental Monitoring and Compliance Branch (EMCM), Air Monitoring Section conducted an inspection at the old GAF Transite manufacturing facility in St. Louis, Missouri on June 15, 1988. The purpose of the inspection was to determine the amount and condition of the exposed asbestos-containing Transite, buried and abandoned on the property.

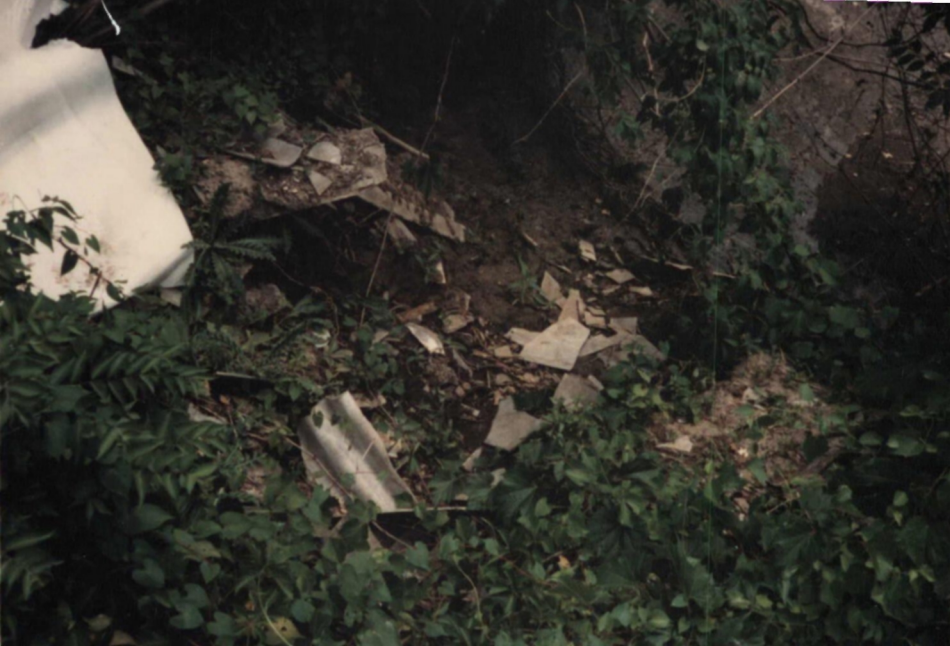
1

Along the creek bank, some erosion has taken place and some Transite board is visible. Along the treelined creek bank, west of the main building, recent grading has taken place, exposing a lot of Transite board. The graded area contains pieces of Transite. Transite pieces were also exposed along the creek bank. The graveled area at the edge of the southwest parking lot also contained a large amount of Transite pieces. Sample SBR60-004 was taken from this area.

Broken transite board along Maline creek bank

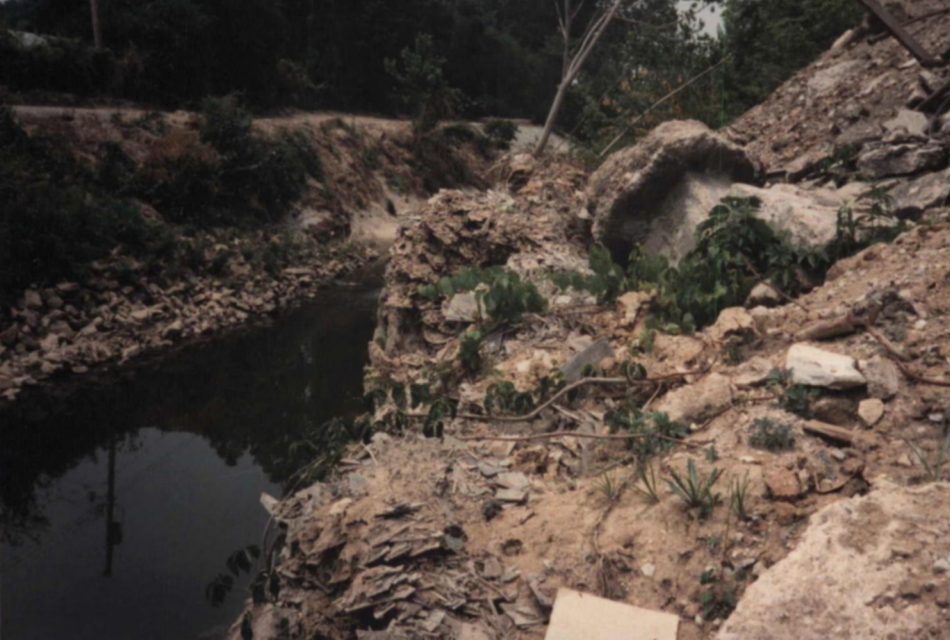
2

Broken transite along Maline creek bank

Sample site SBR60-001

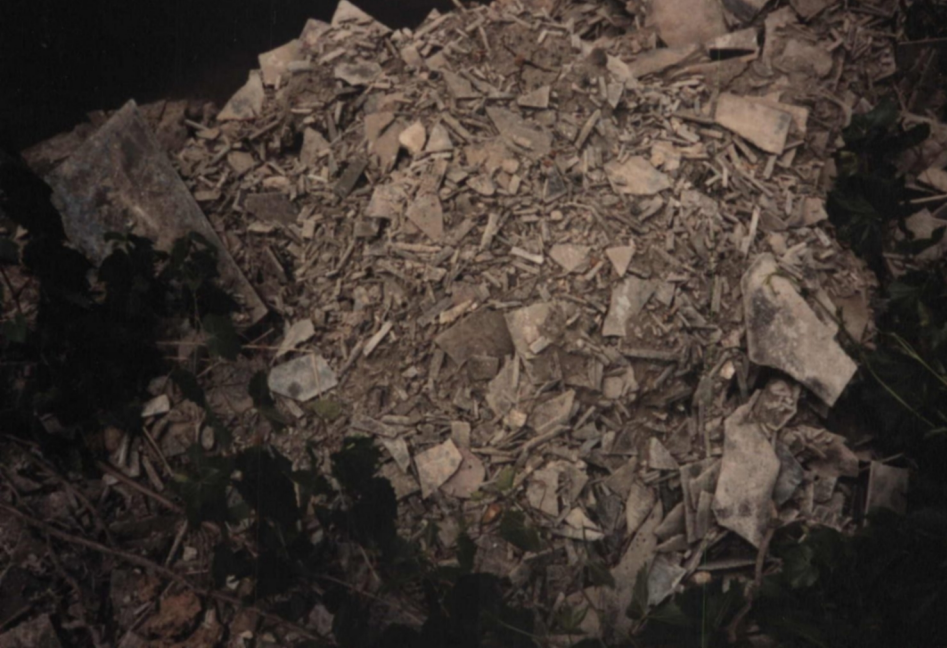
3

Transite pieces along Maline creek

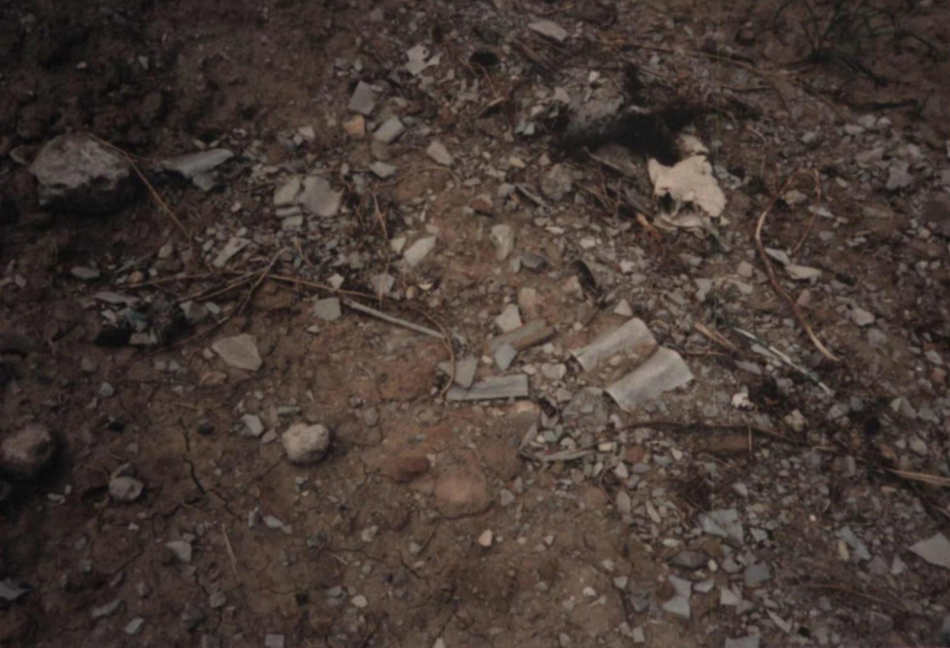
4

Transite pieces in graded area west of main building

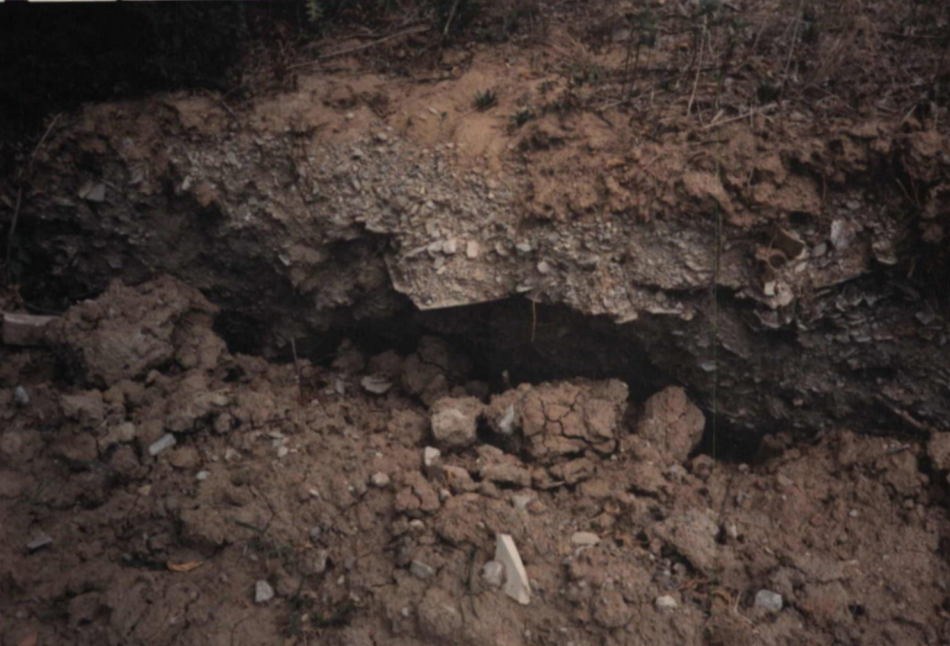
5

Transite pieces in graded area west of main building

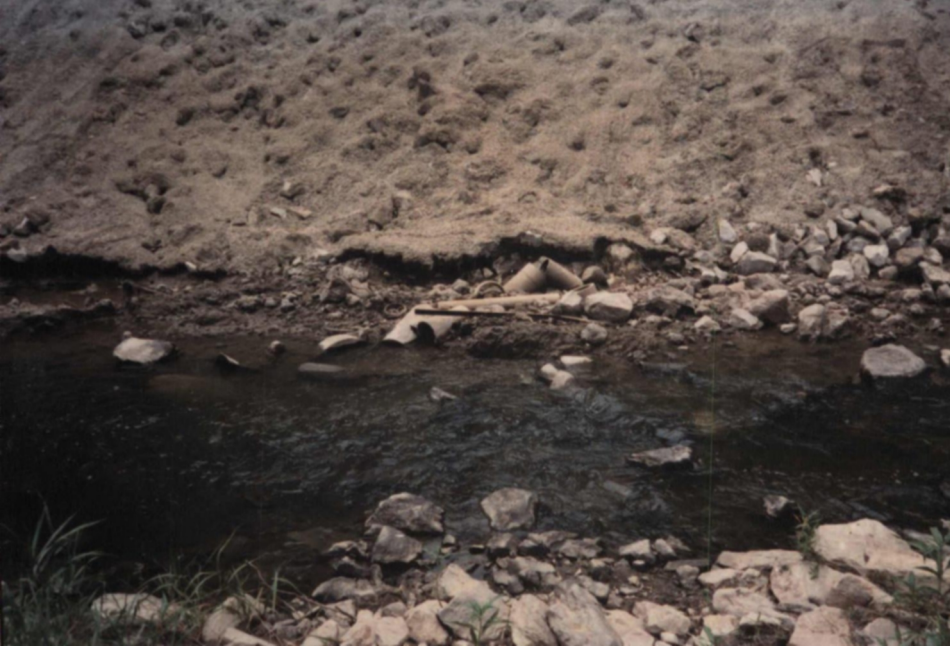
6

Transite pipe in Maline creek

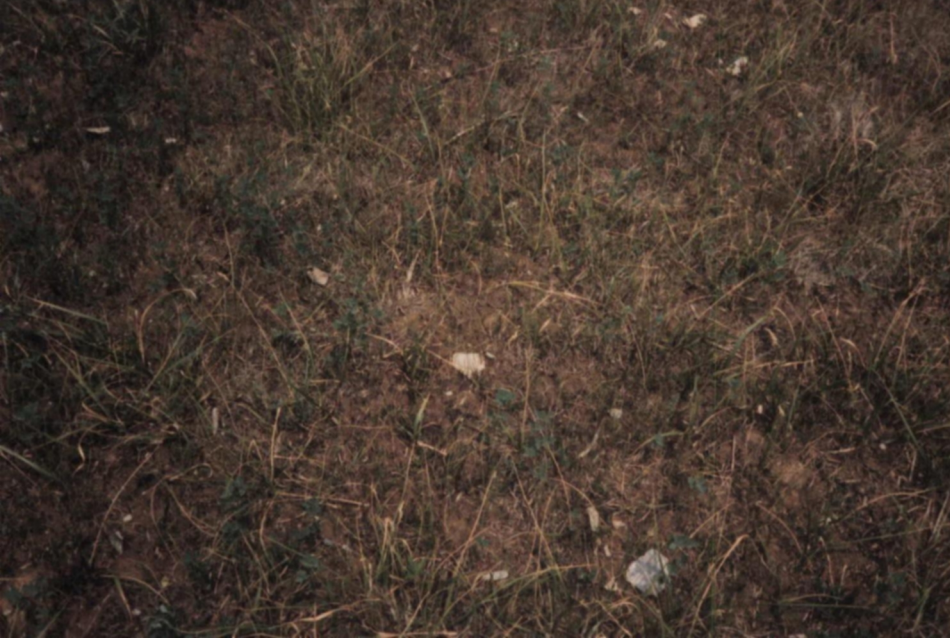
7

That area contained approximately 20 small pieces, and sample SBR60-002 was collected there. The material is cementitious, but when rubbed with the fingers, a powder is seen on the fingers.

Transite pieces on covered waste dump Sample site

SBR60-002

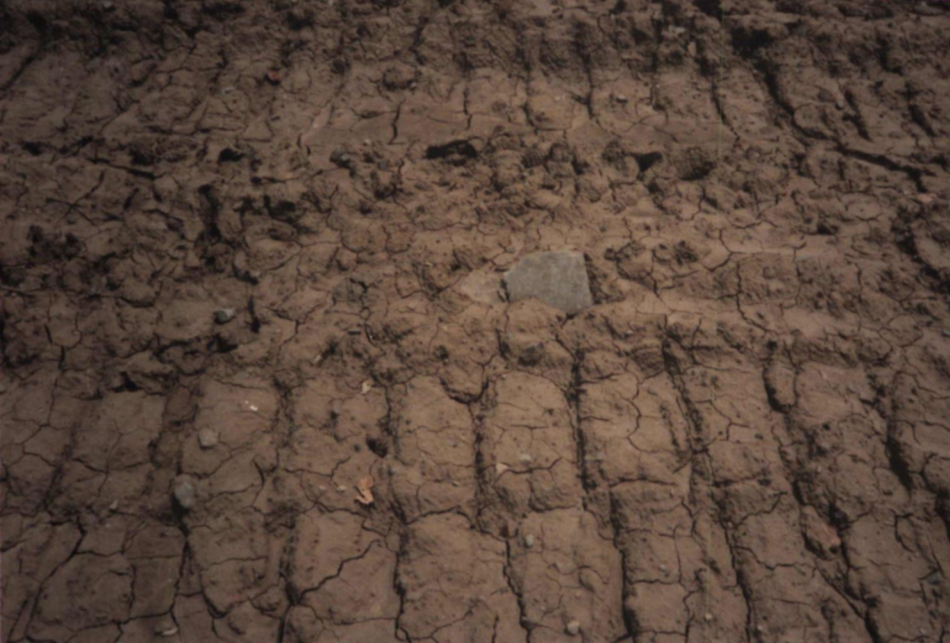
8

The dirt south of the service road has been graded and graveled, and is used as a storage area. Mr. Harris said it was constructed 2 to 3 months ago by Clayco Construction Company, which is also owned by Harold Clark. Along the edge of the graveled lot and the covered waste dump are numerous pieces of Transite. Sample SBR60-003 was obtained from this area. Mr. Harris said that a fence will be built between the waste dump and graveled lot areas.

Northeast corner of graveled lot

Sample site SBR60-003

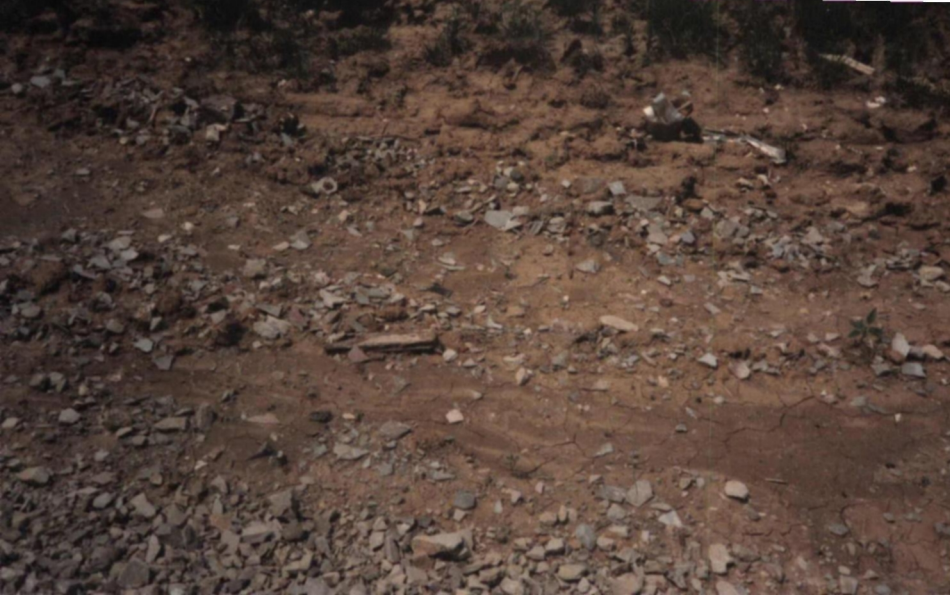
9

Edge of graveled lot - many small transite pieces

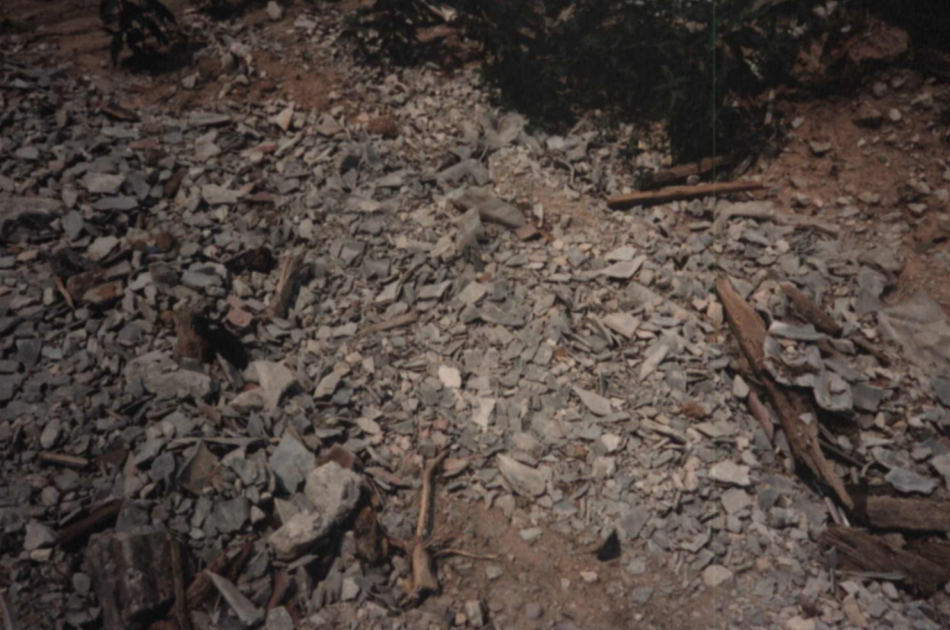
10

Transite pieces next to west parking lot and power pole

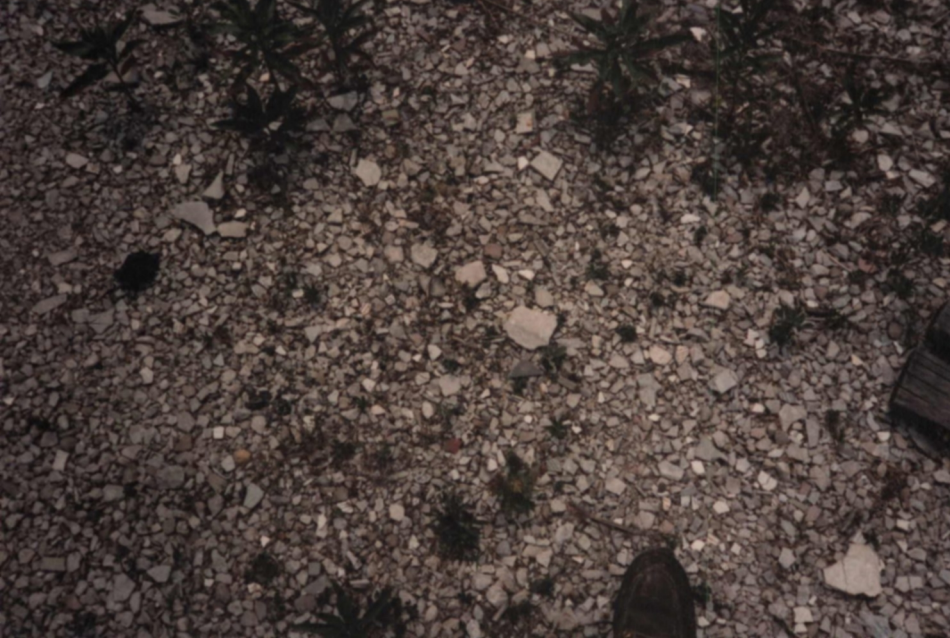
11

Edge of west parking lot-transite pieces

Sample site SER60-004
